Alternative Communications Methods For Electronic Control Modules

ON-ENGINE EXPERIENCE

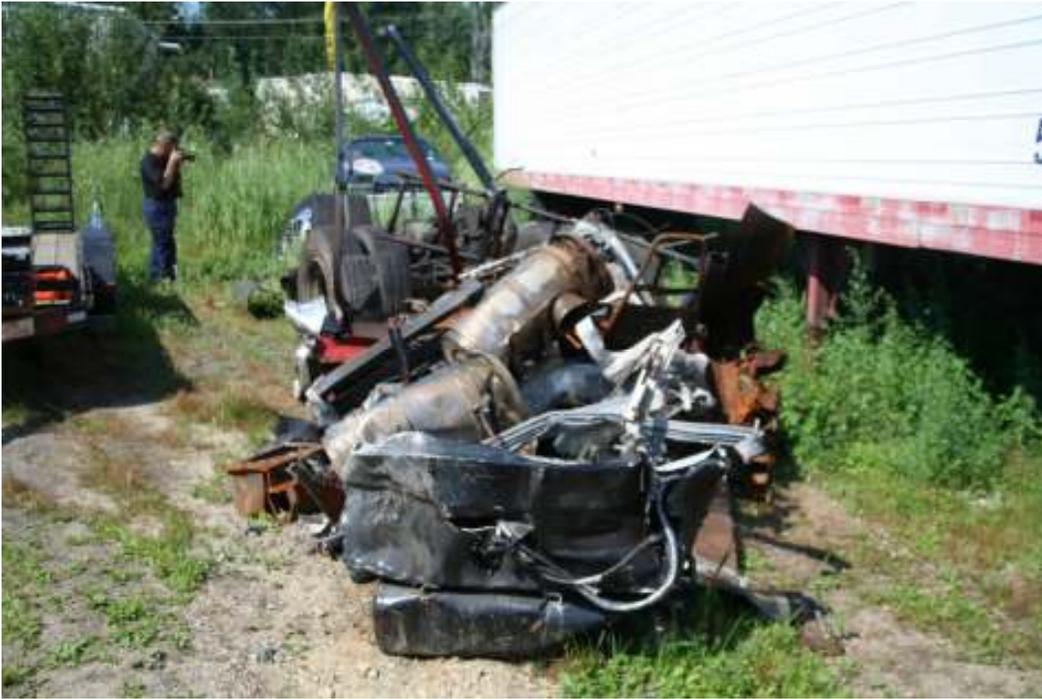
The vehicle was a 2009 Kenworth W900 truck-tractor, towing a refuse compaction semi-trailer. Upon inspection, a significant portion of the locomotive's front walkway and handrail was intertwined with the remainder of the truck-tractor.

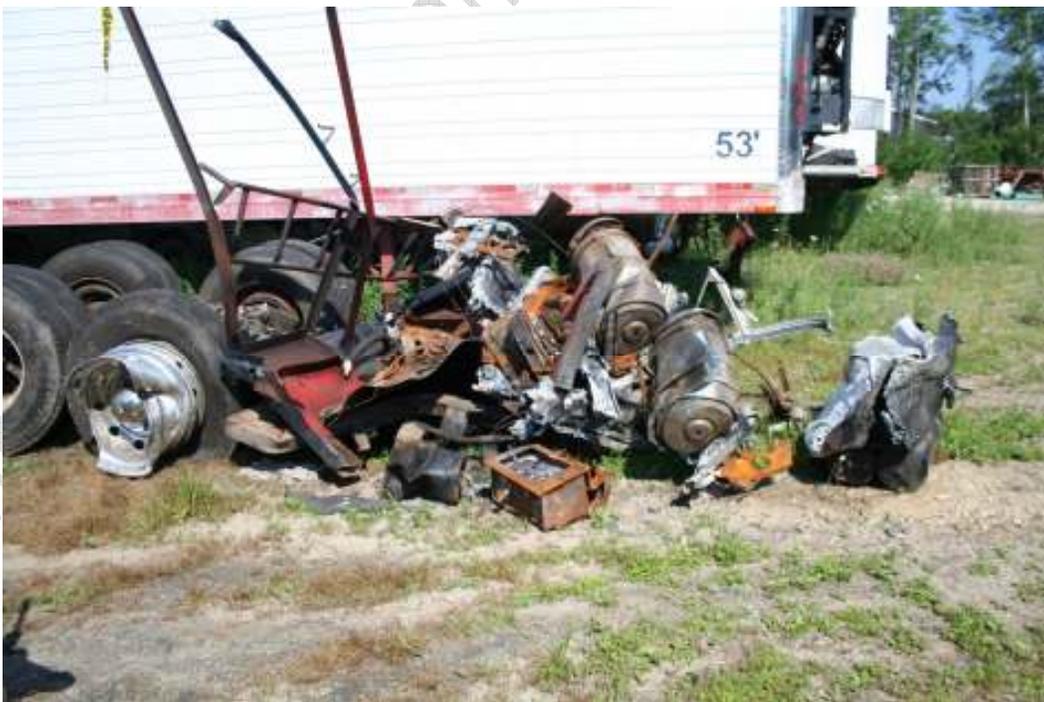
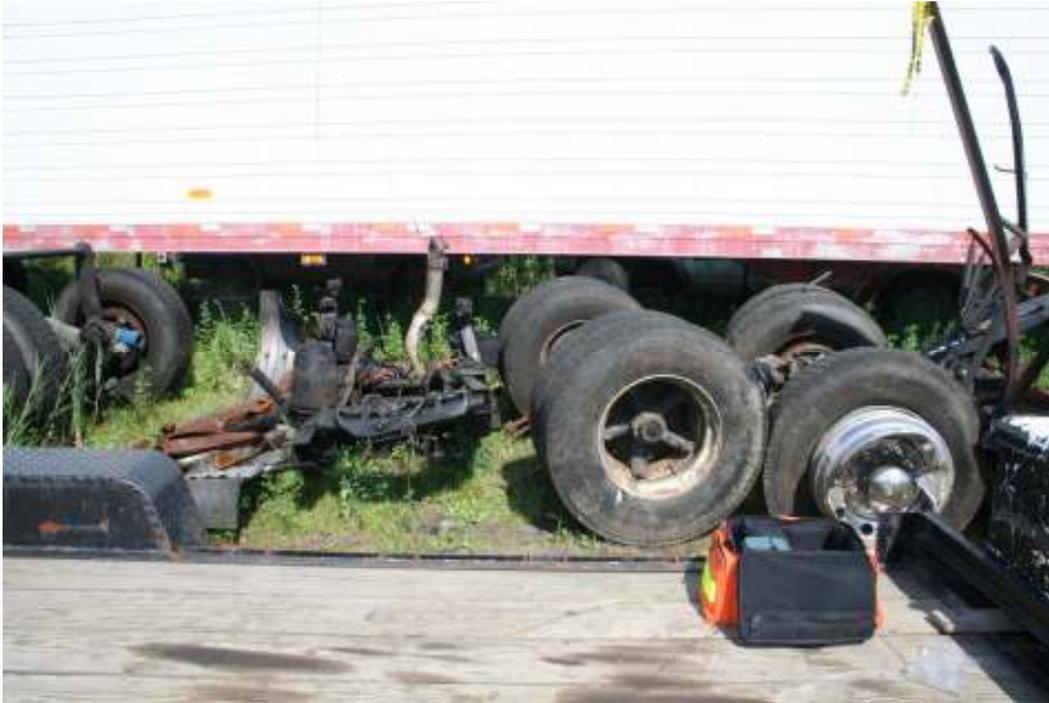
The ensuing fire consumed the anti-lock brake system's electronic control unit. Some remaining foundation brake components were sufficiently damaged to prevent pressure plate/pushrod movement, making assessment of brake performance complex.

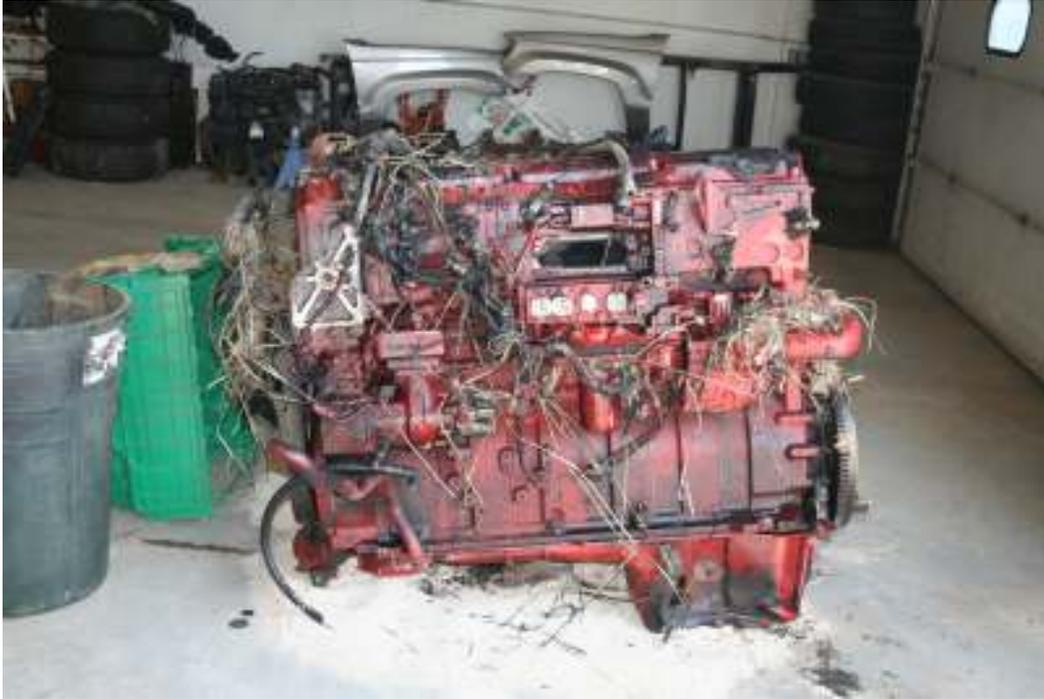
The ISX 07 Cummins engine was recovered approximately 200 feet from the area of initial impact.

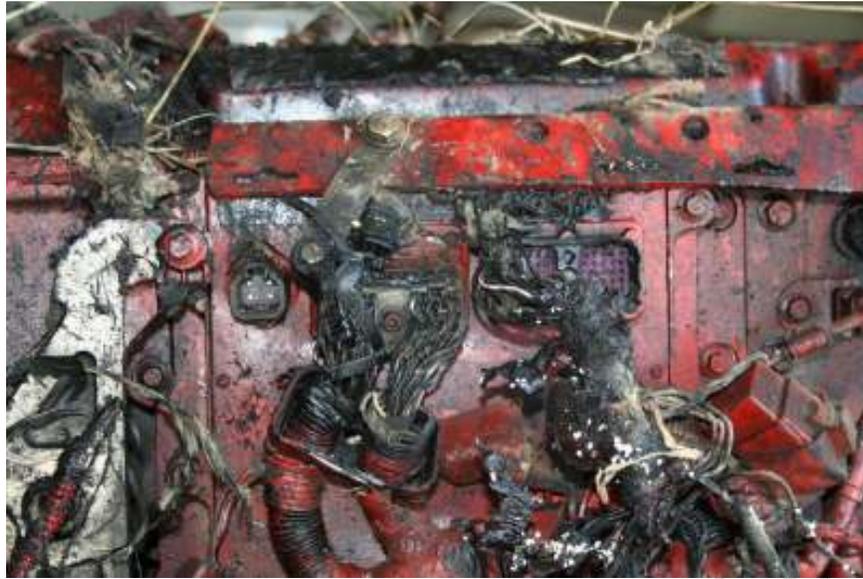
The ECM was damaged. The cab wiring harness was pulled completely out of the connector. The engine harness was secured to its connector, but the connector was broken from the ECM housing.

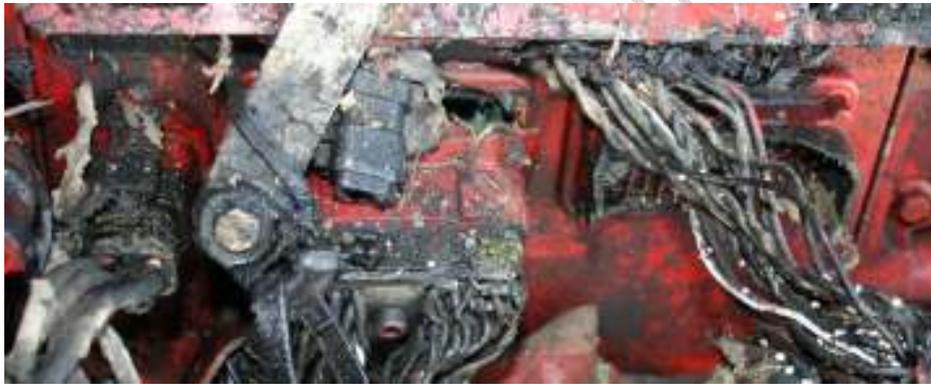
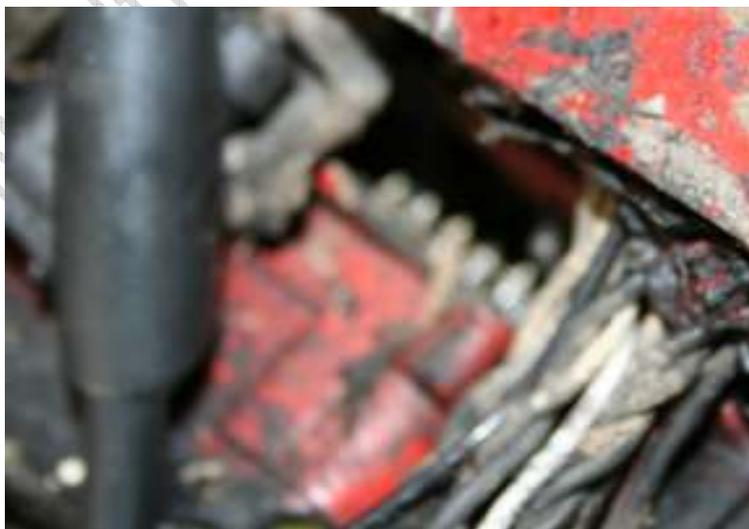
The left side four-pin connector was intact. The corresponding connection of the 3164185 calibration adapter harness could be securely connected. The cab connector was sufficiently

damaged as to prevent a secure mount of the 3164185 calibration adapter harness' programming connection.

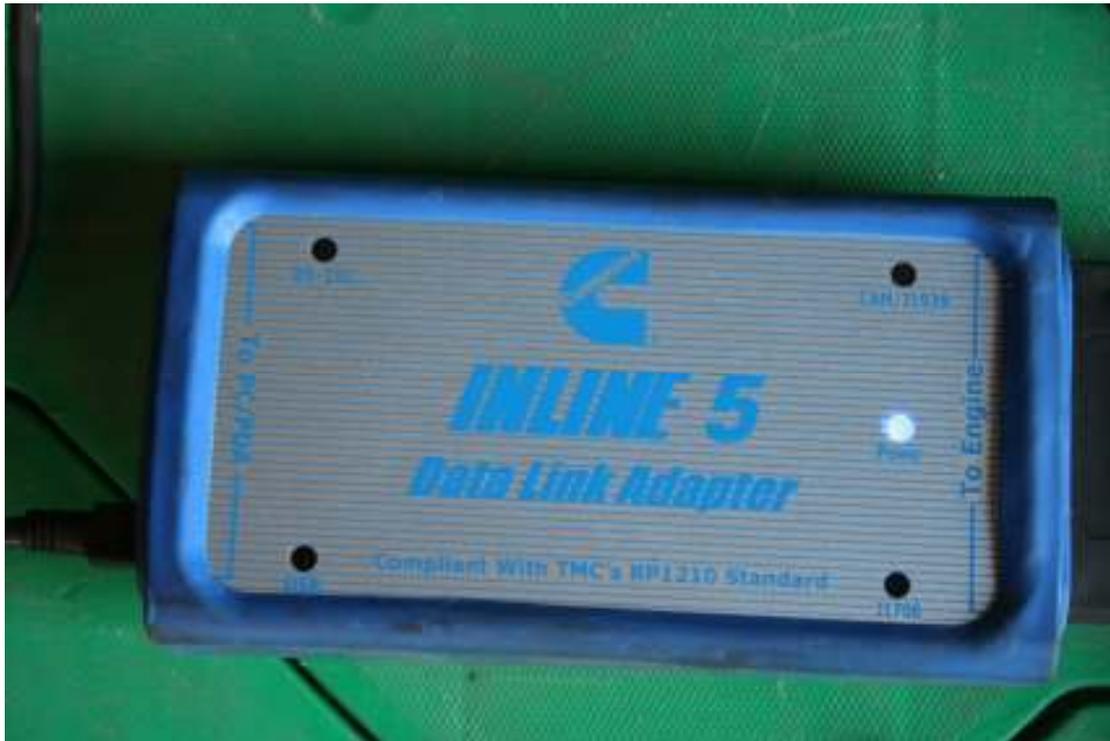
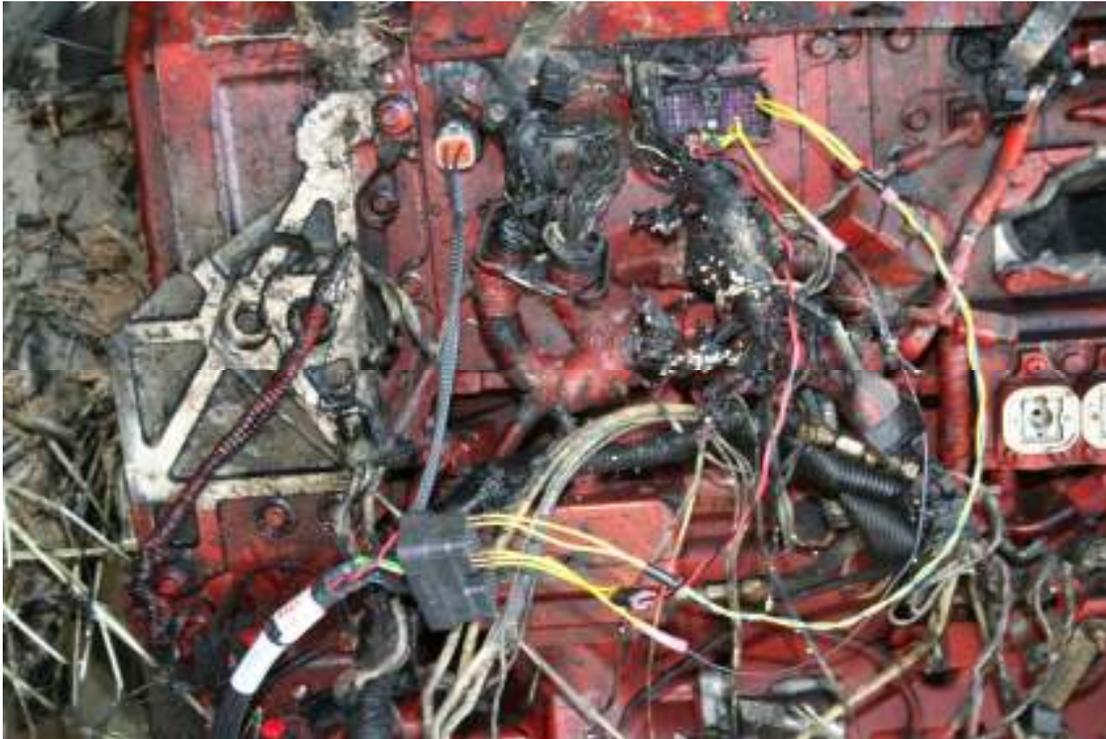
In our initial attempt at communications, specially constructed "Jumper" wires were used to connect the harness female pins to the appropriate ECM male pins to enable communications via the J1708/1939 data links. It was apparent switched power was available from the calibration adapter cable, as the Inline 5 Data Link Adapter was receiving electrical power.

However, communications with the ECM could not be achieved. It appeared switched power was being interrupted by the damage to the ECM's circuit board. Additional "Jumper" wires were employed to complete the calibration adapter harness' intended connections.

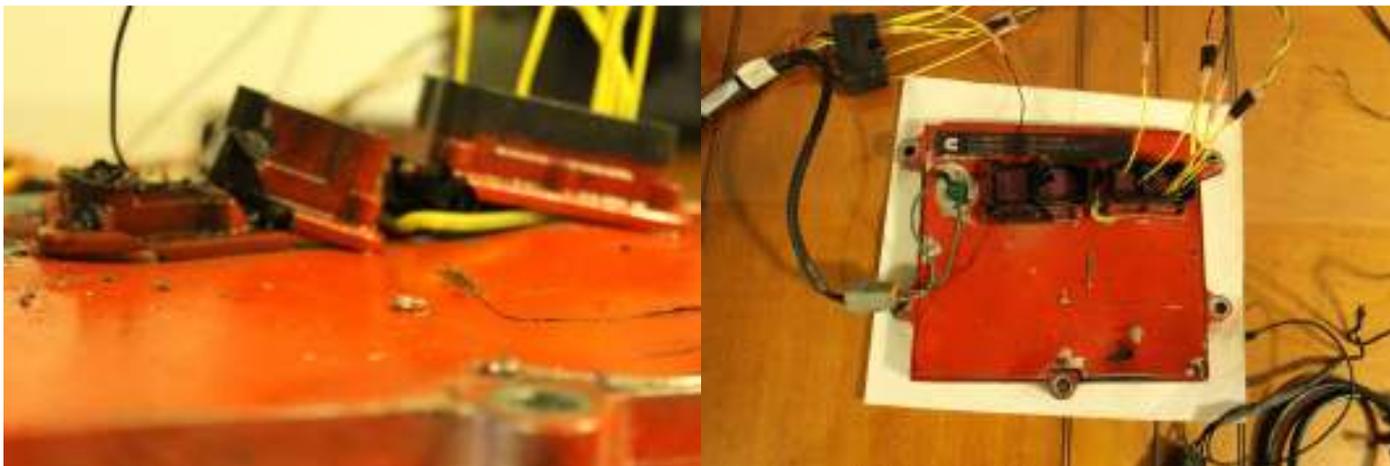
We have had a number of opportunities to acquire data from Cummins ECMs on the workbench. Due to their forward position on the upper left side of the engine, Cummins ECMs are susceptible to damage from direct contact.

The leading four pin connector and front seventy-two pin connector are the most at risk, but the rearmost seventy-two pin connector is not immune. In this case, the housing of the four pin connector was destroyed and had to be removed to access the pins. Also, a clamp was needed to push the rearmost seventy-two pin connector back onto the circuit board. Once the connector was back in contact with the circuit board, jumpers were installed to achieve communications.

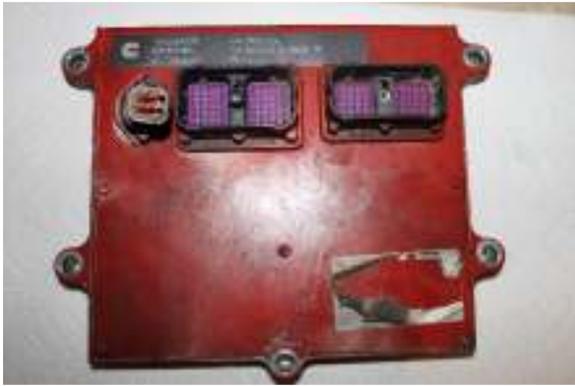
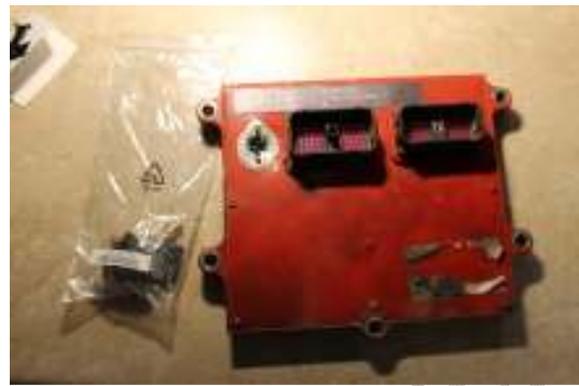
In another case, the four pin connector appeared to simply have been pulled away from the circuit board. However, upon closer examination, the connector required removal, as its only connection to the ECM were the mounting screws. Careful work with a Dremel tool severed the screws, which could then be removed to prevent shorting.

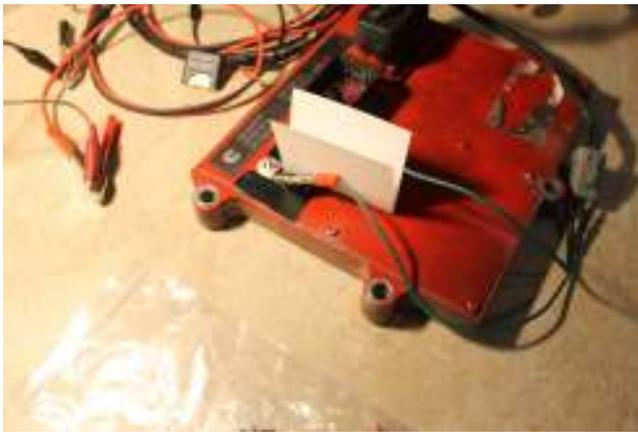
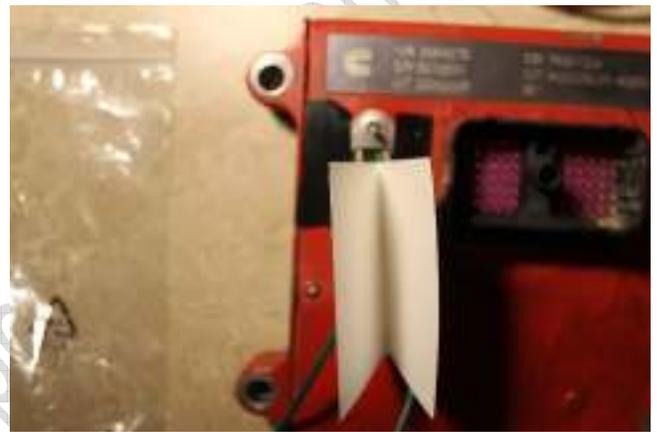
Once the four pin connector was removed, special jumpers were constructed to allow clips to grasp the pins' connections on the terminal ribbon built into the circuit board.
