Alternative Communications Methods For Electronic Control Modules

ON-ENGINE EXPERIENCE

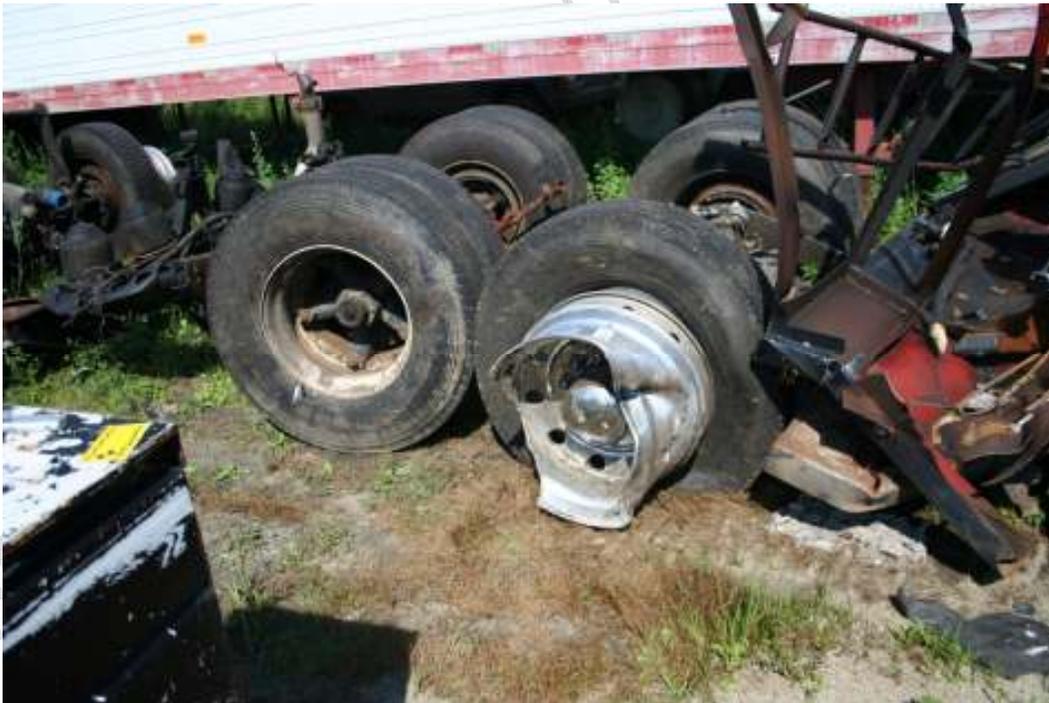
The ensuing fire consumed the anti-lock brake system's electronic control unit. Some remaining foundation brake components were sufficiently damaged to prevent pressure plate/pushrod movement, making assessment of brake performance complex.

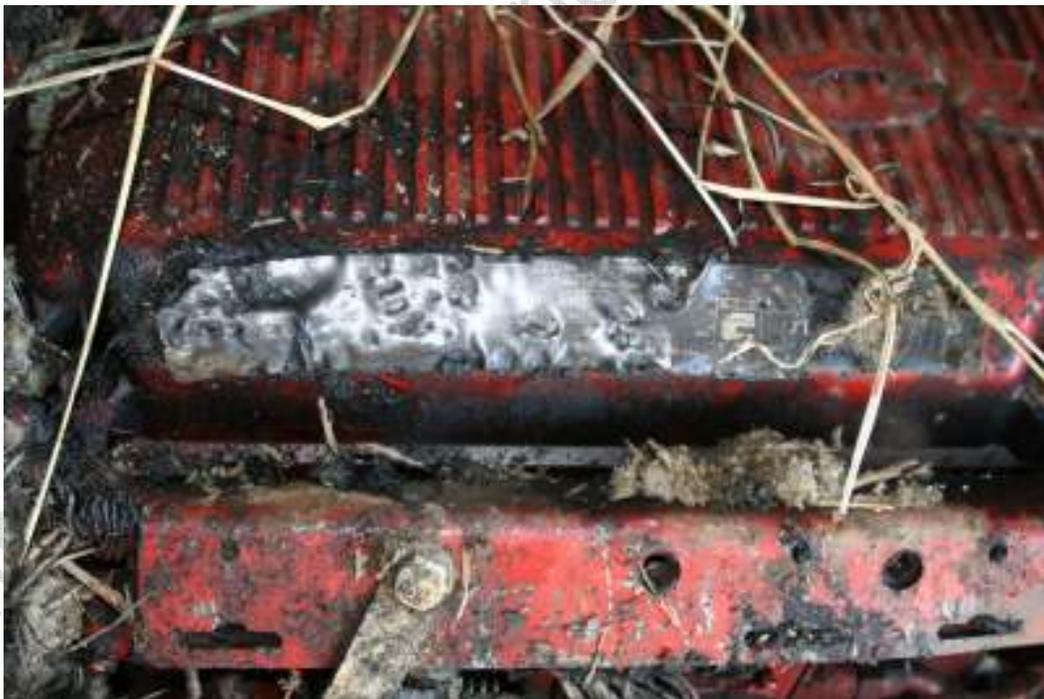
The ISX 07 Cummins engine was recovered approximately 200 feet from the area of initial impact.

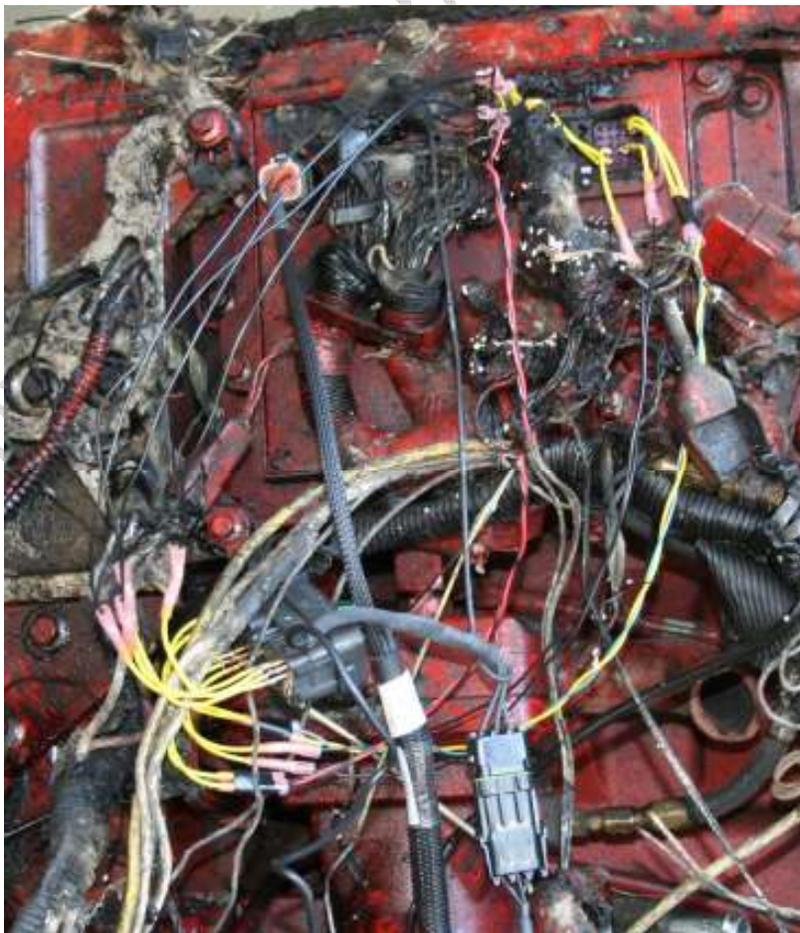
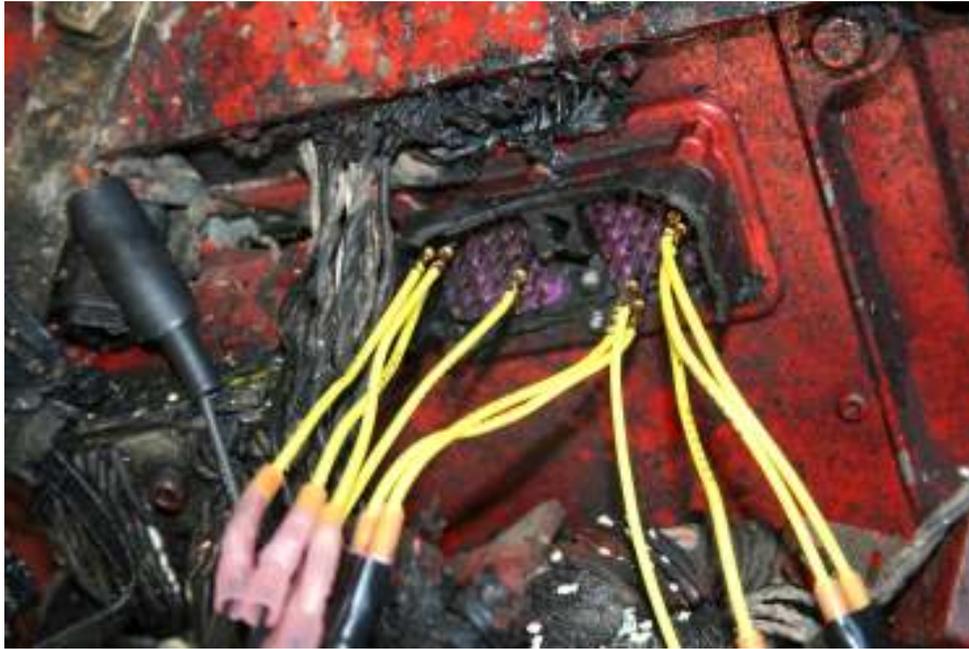
However, communications with the ECM could not be achieved. It appeared switched power was being interrupted by the damage to the ECM's circuit board. Additional "Jumper" wires were employed to complete the calibration adapter harness' intended connections.

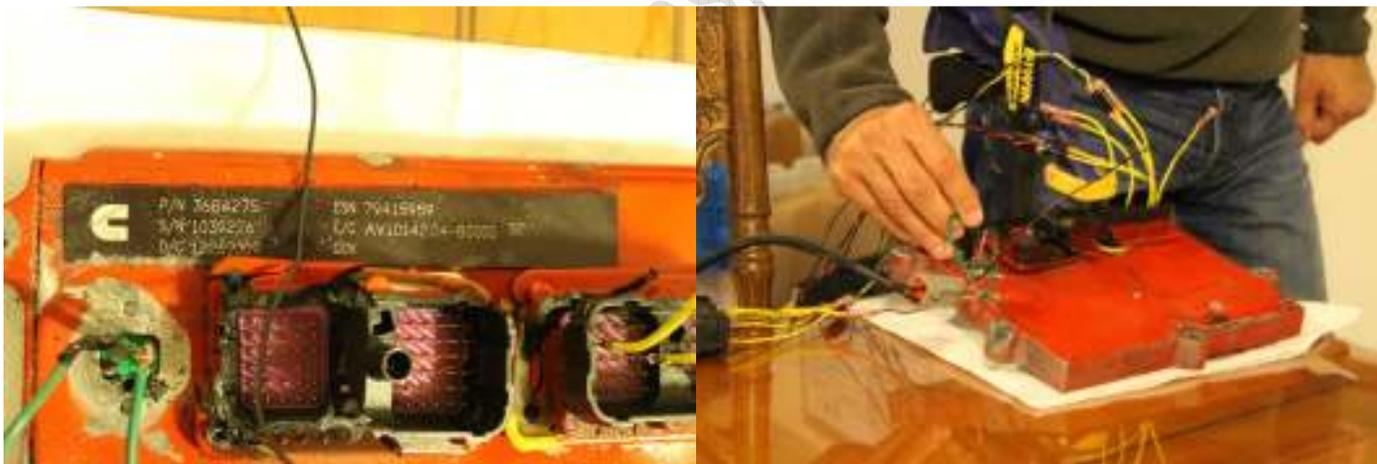
The leading four pin connector and front seventy-two pin connector are the most at risk, but the rearmost seventy-two pin connector is not immune. In this case, the housing of the four pin connector was destroyed and had to be removed to access the pins. Also, a clamp was needed to push the rearmost seventy-two pin connector back onto the circuit board. Once the connector was back in contact with the circuit board, jumpers were installed to achieve communications.
